# Test report

Report ID	LXW-20171200205
Product name	Electronic Crane Scale
Entrusting party	Fidelity Measurement Company Limited
Testing Party	Fidelity Measurement Company Limited
Test type	Entrusted test

## Test report

## 2. 5-Times load destruction test

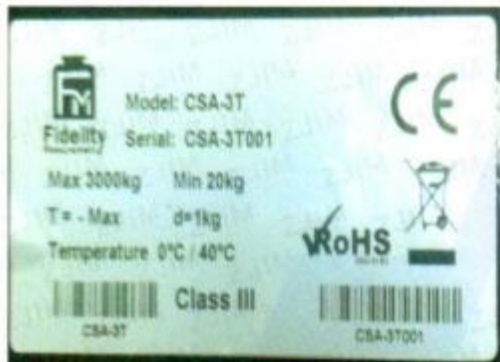
</div> <p>Name of sample</p>			<div>

Sample Sub-No.	Specifications and model (Load and sample name)	Sample batch (serial) No.	Technical requirements	Test result
01	CSA-3T (3t Electronic Crane Scale)	CSA-3T001	The load was continuously added until the 3-times load, namely the force of 88.2kN (9t), and the load were maintained for 3min. The test samples were not damaged.	No destruction Conforms to requirements
			The load was continuously added until the 4-times load, namely the force of 117.6kN (12t), and the load were maintained for 3min. The test samples were not damaged.	No destruction Conforms to requirements
			The load was continuously added until the 5-times load, namely the force of 147.0kN (15t), and the load were maintained for 5min. The test samples were not damaged.	No breakage Conforms to requirements
<div>
